LAKE ELLIS DAM
MA 00005

PHASE I INSPECTION REPORT
NATIONAL DAM INSPECTION PROGRAM

APRIL 1981

Identification Number:	MA 00005
Name of Dam:	Lake Ellis Dam
Town:	Athol
County and State:	Worcester County, Massachusetts
Stream:	Mill Brook
Date of Inspection:	December 4, 1980

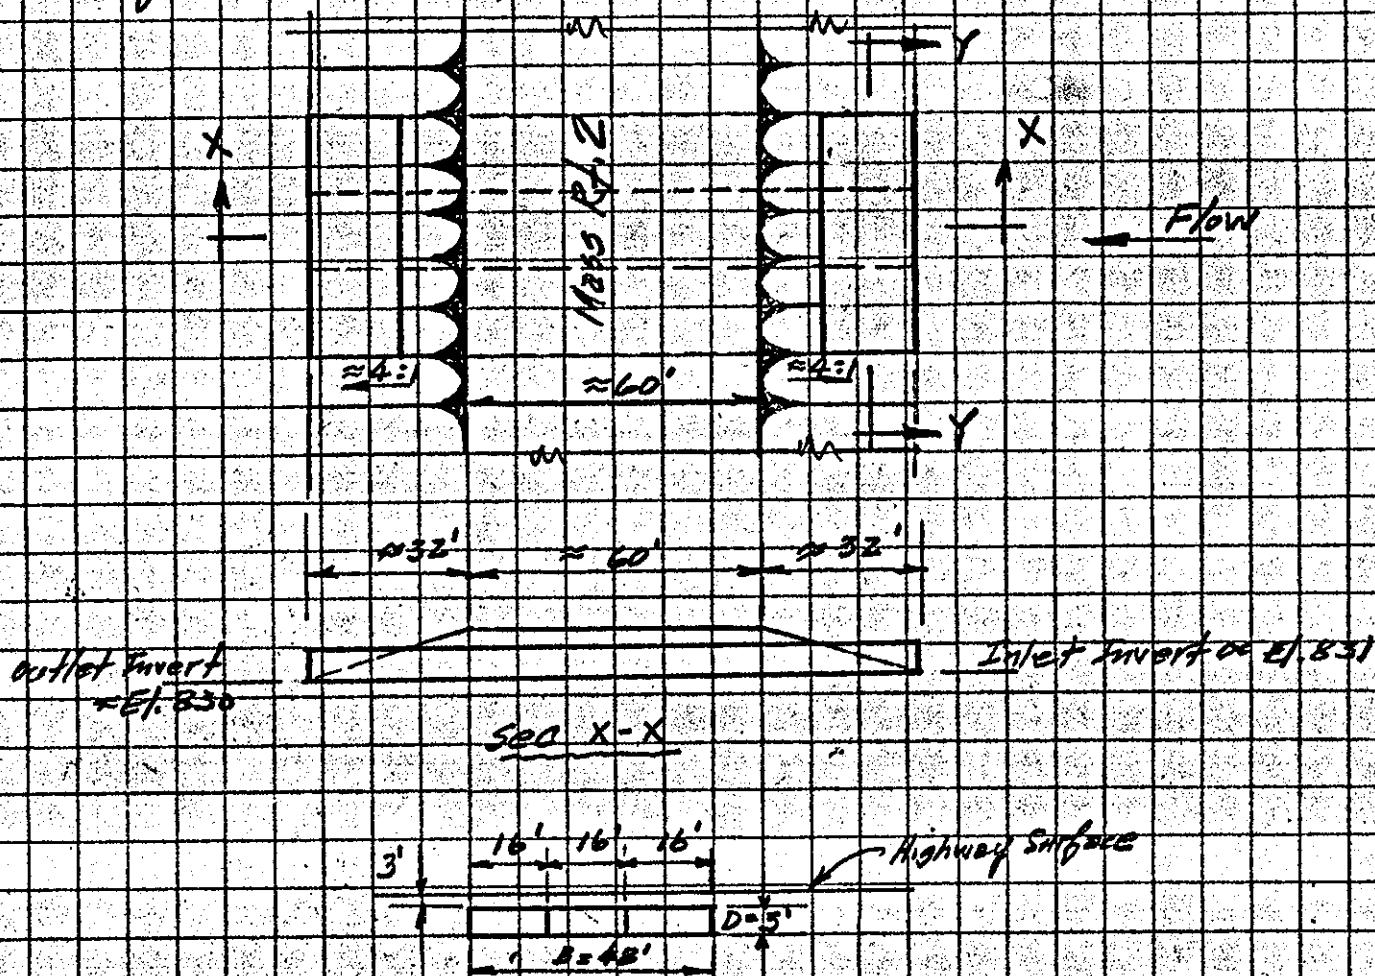
Spillway @ Mass. Rt. 2

Discharge thru Triple Culverts

Assume inlet control because culverts outlet into marsh area at least 1500' wide
